**Regarding
Performance Designs Service Bulletin # 002
Relative Workshop Service Bulletin # 230505.**

SERVICE BULLETIN

Date: 5/23/2005
Service Bulletin #: PDSBLTN-002, RWSBLTN-230505
Subject: Inspection of Tandem VTC-III reserves (VR-360) A Line Attachments and Steering Lines.
Status: MANDATORY

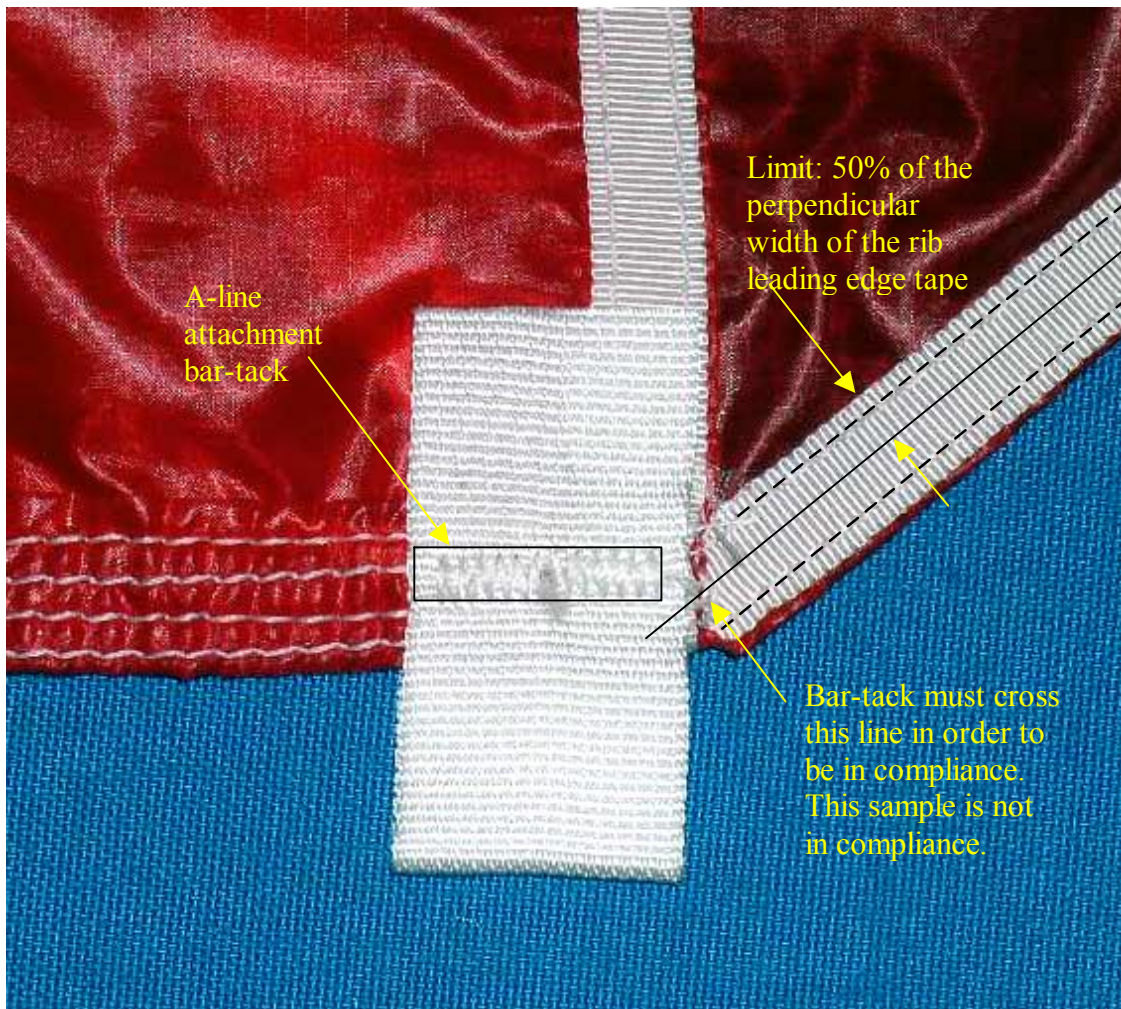
Figure 1 Rib leading Edge Tape Inspection

The A-line attachment bar-tack must be sewn through at least 50% of the width of the loaded-rib leading edge tape.

- a) Using a ruler, find the centerline of the rib-leading edge tape. This may be lightly marked with pencil if necessary.
- b) Using the ruler, extend the centerline of the leading edge tape to the vicinity of the bar-tack.
- c) Observe the location of the bar-tack with respect to the tape centerline.

1. Inspect all ten of the A-line attachments per the attached Inspection Procedures, Section 1, A-line Attachment Inspection Procedure.
2. If any of the 10 A-line tab bartacks do not comply with the proper alignment the parachute must be brought into compliance by an approved service facility. Adjusting the line tab requires a specialized heavy-duty bartacker not commonly found in the field.

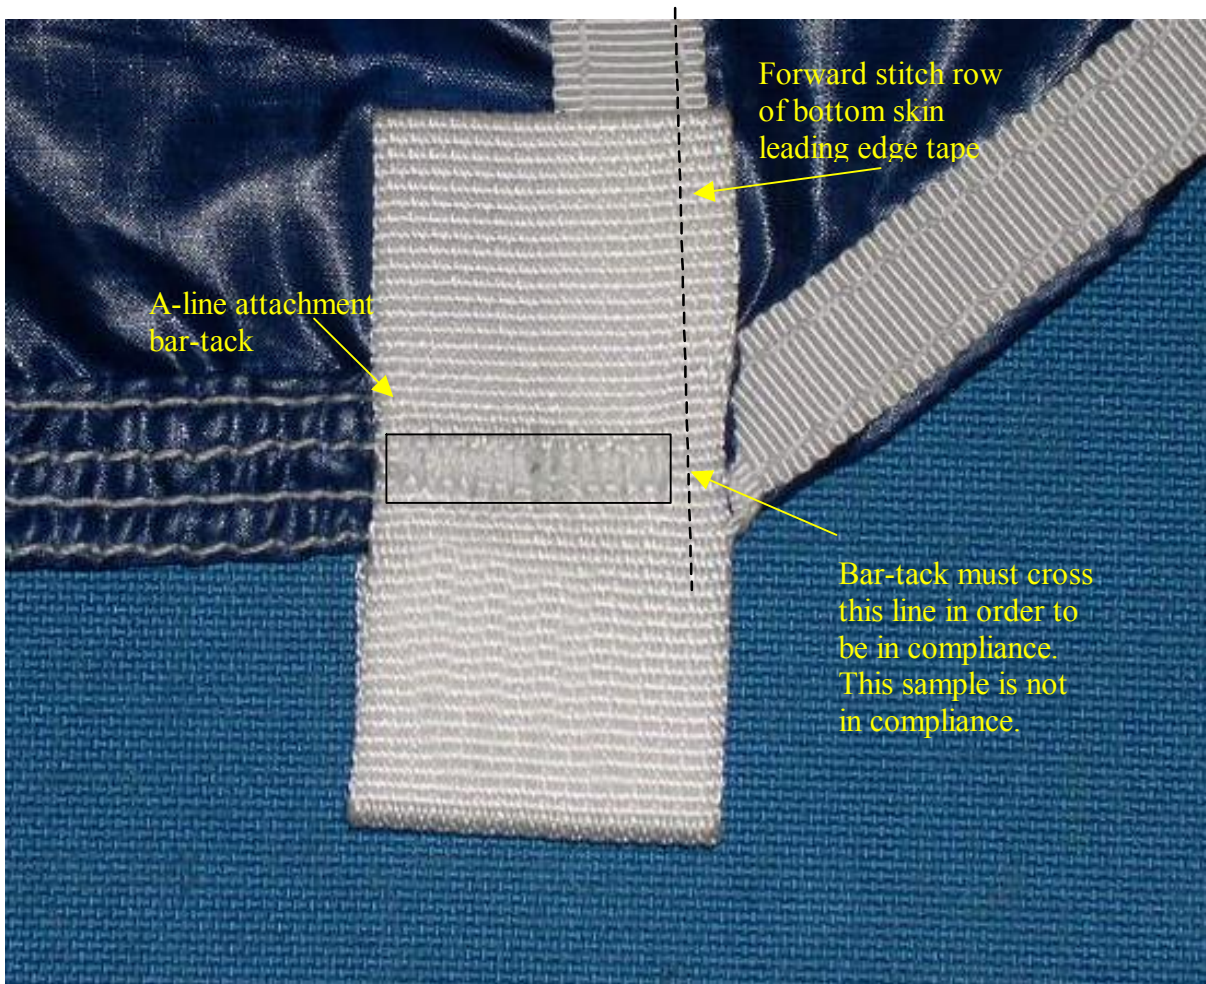
Figure 2- Bottom Skin LE Tape Inspection

The A-line attachment bar-tack stitching must extend forward of the forward stitch line on all the bottom skin leading edge tapes. Inspect both sides of tab.

- Locate the forward stitch row of the bottom-skin leading edge tape.
- Using a straight edge, extend the forward stitch line of the leading edge tape to the vicinity of the bar-tack.
- Observe the location of the bar-tack with respect to the tape stitch row. The bar-tack may or may not overlap the edge of the line-tab, but it must cross the stitch-row and be going through the tab at this point.
