| Basik air concept 2010 RN 97 83340 Le Luc FRANCE | SERVICE BULLETIN MANDATORY | N° /AN Date: 03 /11 /05 Page 1/6 |

| Reference ADV (xxxx) | Designation Harness-container Advance | SN# Concerned All kind with chest strap type 8 (42 mm large) |

Subject: Addendum of S.B. n° 051101 from 3/11/05

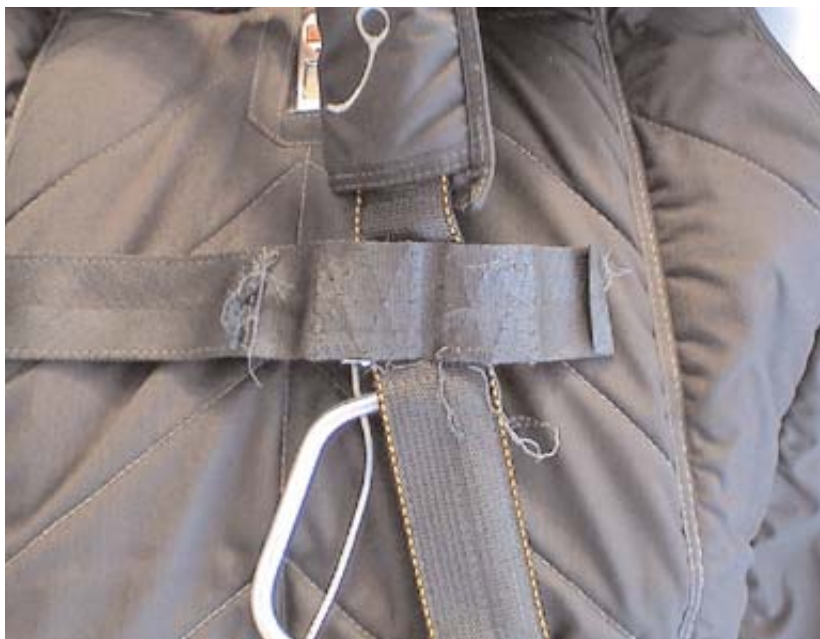
After eyesight some photos that we've recovered (we haven't still the equipment to disposal), the main pilot chute inflated on the right side and a very hard opening happened while the student was in the head down position left slice side. This hard opening has provoked the stitches failure of the chest strap and of some secondary stitches as well.

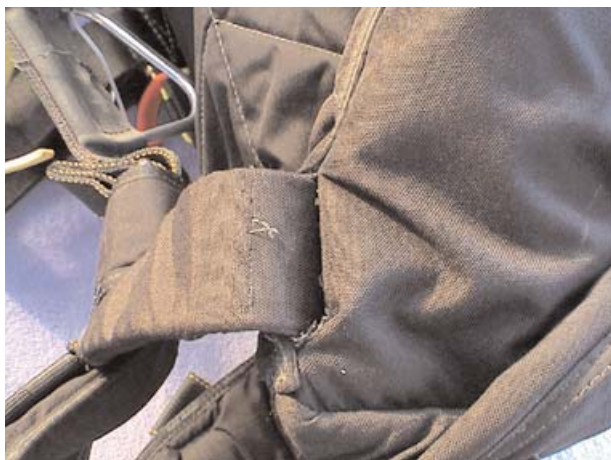
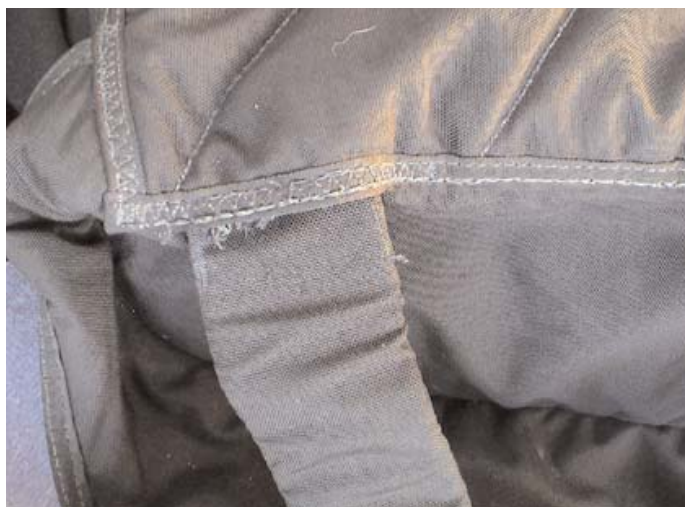
Container junction with the lateral webbing as been slightly damaged too.

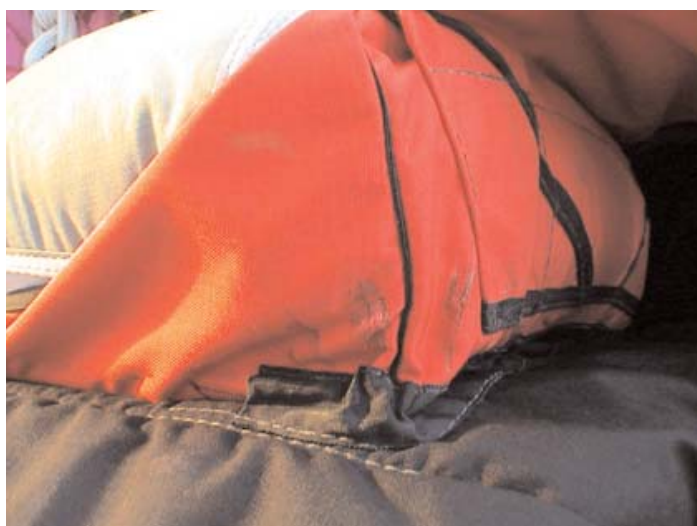
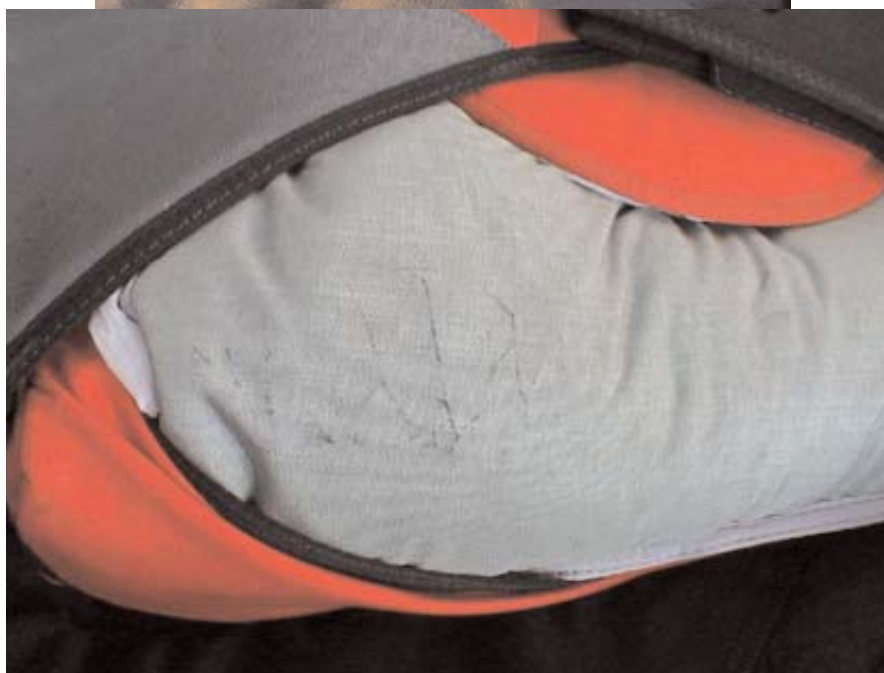
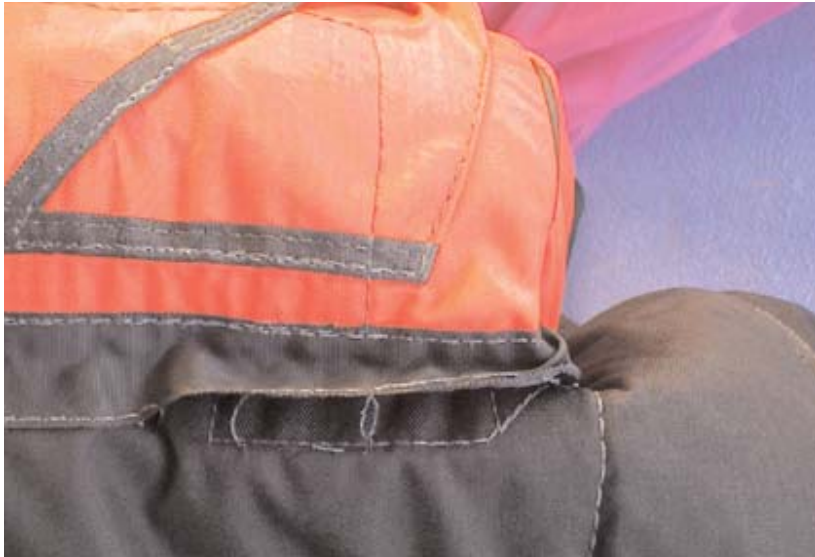
Several burns done by the main canopy lines and risers are on the reserve container divider flap and on the reserve bag as well.

Stiches from the reserve container reinforcement tape are damaged too.

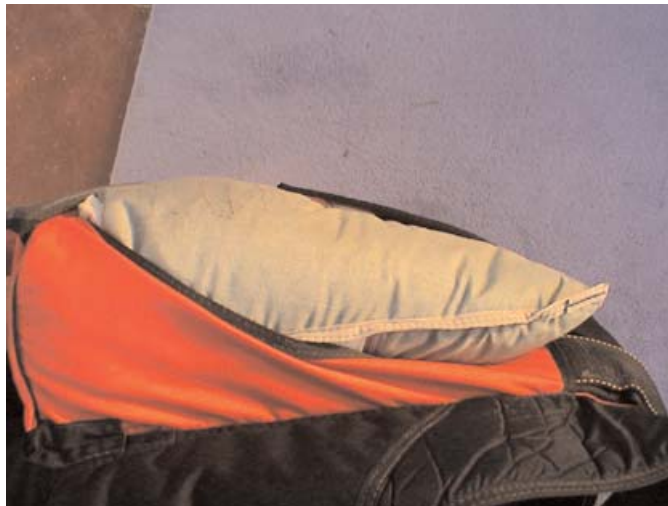
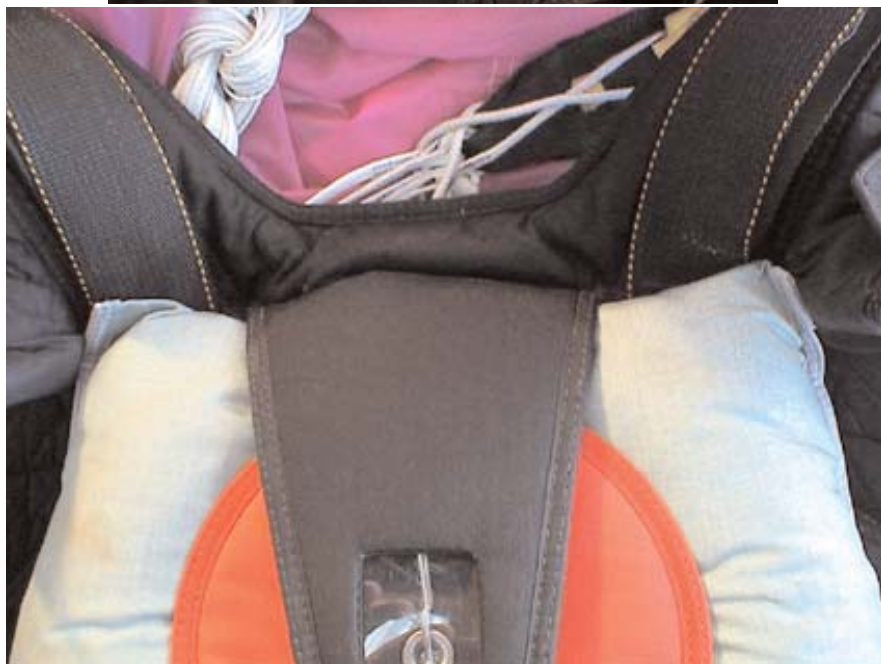
Because of the important stress the reserve bag has been push downward the bottom of the reserve container. The reserve pin stayed secured. This shown how big the forces transfer has been developed.

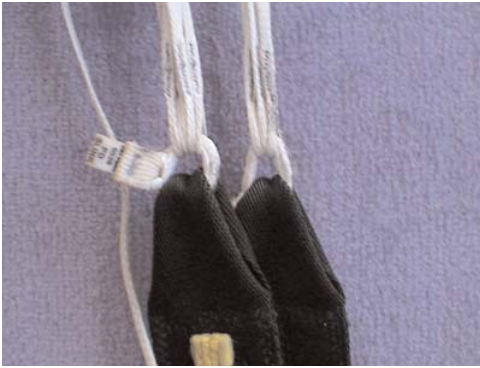
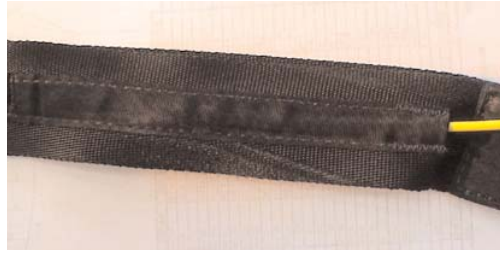
Left main riser grommet has been a bit damaged (no picture) and a burn can be seen on it. The riser lengthen up to 1 cm.

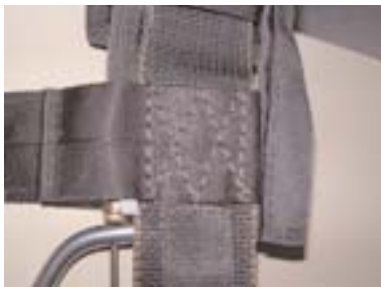
Old conception

We have seen that the method of conception of the chest strap can be made in a better way. This method will avoid any fall of the user from the harness in such situation. We are suggesting to make a complete confluent wrap with the chest strap webbing around the left main webbing. (right picture) instead having just a part of the webbing around it (left picture). By this way in case of seams failure the chest strap webbing will remain to protect the user of any falling possibility. Elasticity differences between type 7 and type 8 webbing and this type of conception used are not the best method in such dissymmetrical stress and hard opening. Seams cannot resist in such situation because stitches cannot be as elastic as the webbing is. It is evident that this kind of separation of the chest strap from the main lift webbing can happen to any kind of conception which doesn't not integrated a complete confluent wrap around the MLW. **The conception we used and those who consist to insert the chest strap between the MLW (even if it is stronger) do not protect at all the user from a falling possibly from its harness in case of such violent opening and stress transfer to the chest strap.**

We are asking to have all Advance harness-container equipped with a type 8 chest strap which not used a confluent wrap to be return for modification to our factory. This modification can also be done into a certified rigging loft. This modification is mandatory and it is totally free of charge for the customer.
