PARACHUTES AUSTRALIA

SERVICE BULLETIN No PA SB0901

SUBJECT: 3-RING RISER INSPECTION

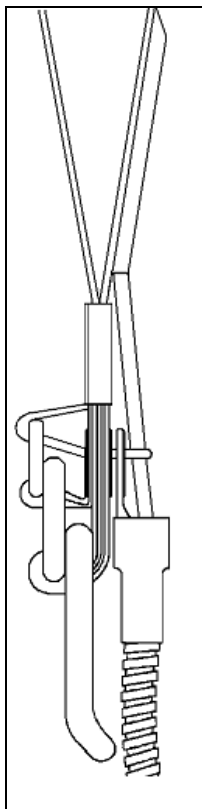
While 3-ring risers may be constructed of different materials the following points define the proper criteria for a correctly built 3-ring riser when attached to the harness ring and put under moderate tension.

- The rings should overlap each other and maintain metal to metal contact between each other.
- The rings should be aligned in parallel planes.
- The smallest ring should not be pulled snug against the grommet by the locking loop which should be long enough to give it some play.
- The locking loop should go straight through the riser grommet on its way to the cable housing end fitting.
- It should be checked that NO suspended load is supported by the cable housing and locking loop due to the cable housing being incorrectly positioned in the harness or being too short.

PA manufactured 3- ring risers **not** meeting the requirements of APF Service Bulletin APF010801-C must be sent to PA for correction and return at no charge.
