TECHNICAL ADVISORY

N° AV070718
Date 18/07/2007
Page 1/2

Advance Tandem system T1 and T2

Equipement concerned: Advance Tandem T1 and T2 MFG before April 2006

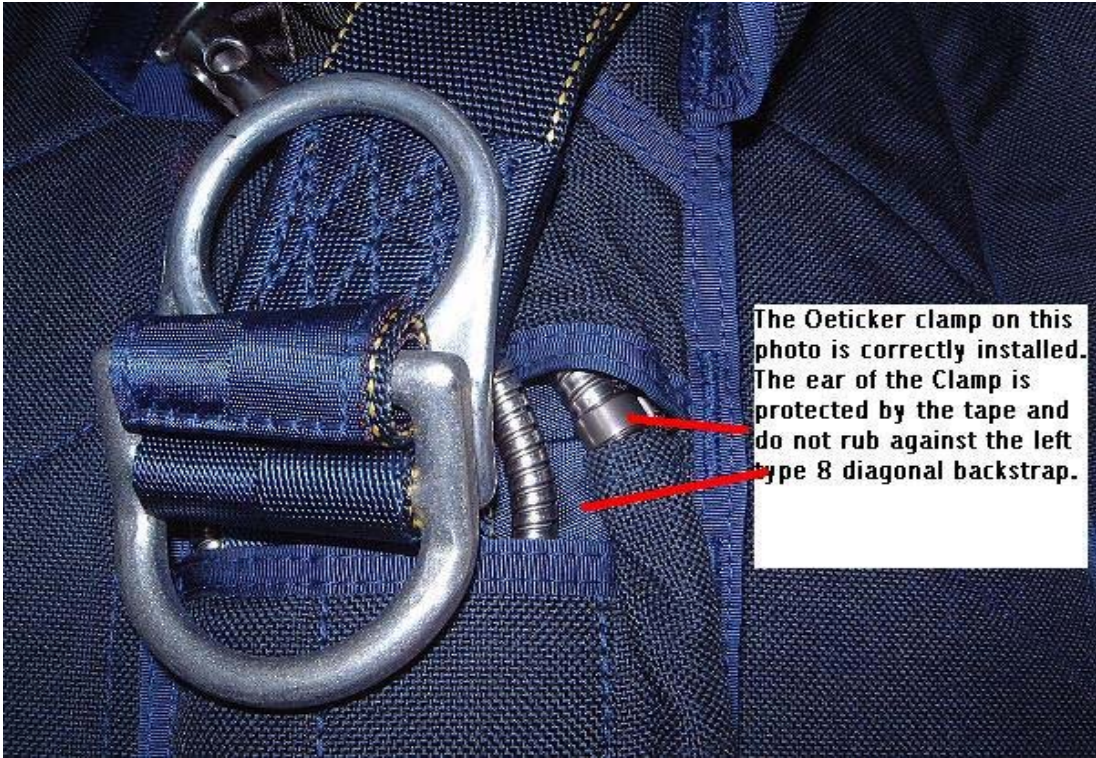
The Oeticker clamp on this photo is correctly installed. The ear of the Clamp is protected by the tape and do not rub against the left type 8 diagonal backstrap.

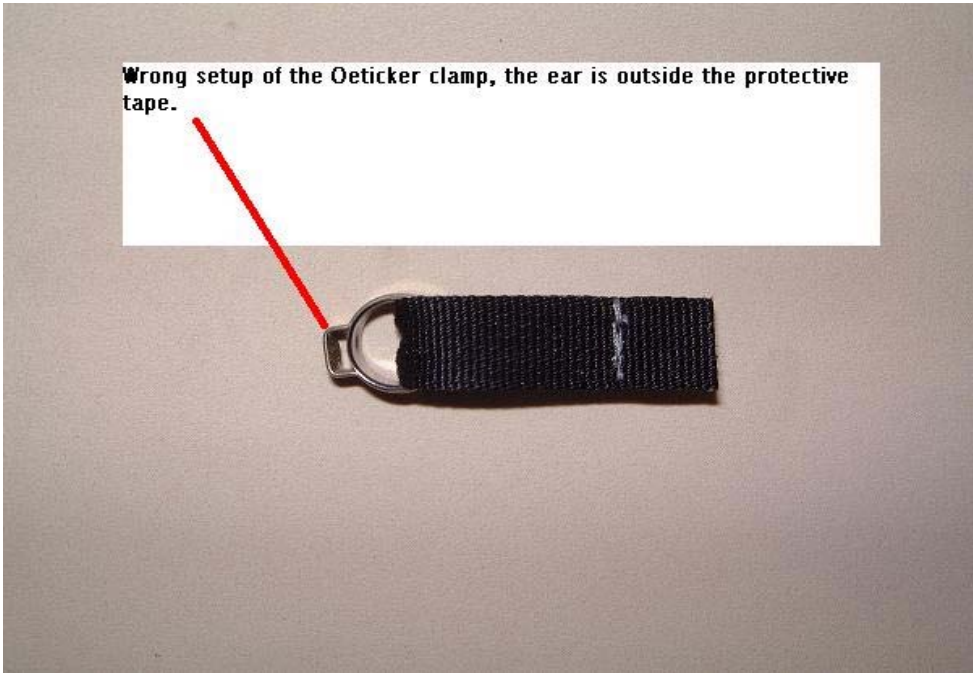
Reasons: Potential risk of damage on the type 8 webbing because of the clamp friction on the webbing.

Wrong setup of the Oeticker clamp, the ear is outside the protective tape.

Works: If a damage is found you must get in touch with us at basik.fr@free.fr
A certified Master Rigger can make the repair after getting our repair plan.
If no damage is found but the Oeticker clamp is mouting the wrong way the clamp must be uncrimped, turn back inside the tape and reset.
If you cannot reset it a hand tacking can be made to maintain the housing.
This must be done by a certified Master Rigger

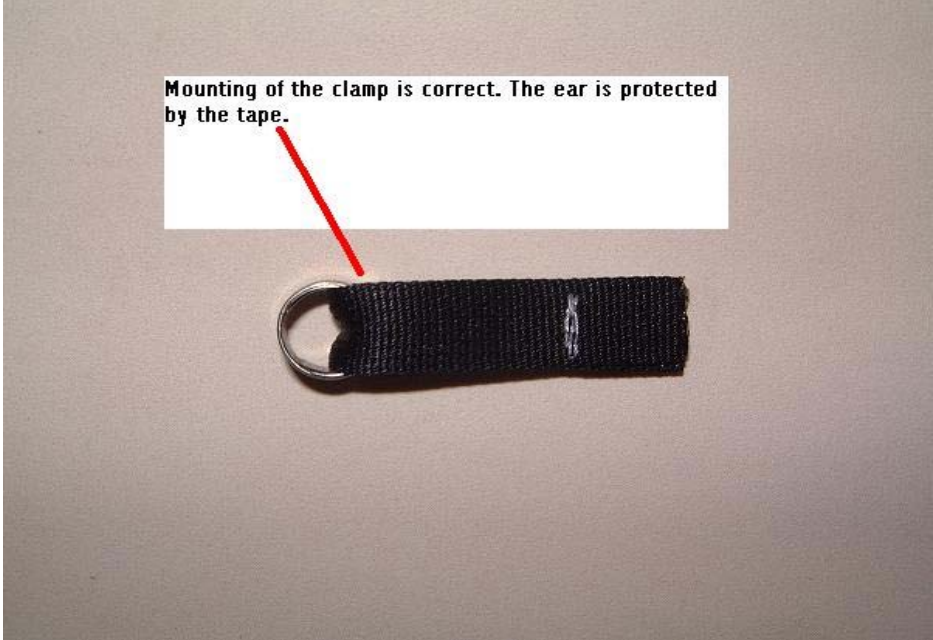
Mounting of the clamp is correct. The ear is protected by the tape.
