SERVICE BULLETIN SPSB005
IH101-3 (HIP RING MLW) AND IH101-4 (4 RING MLW) RING DAMAGE
INSPECTION

SERVICE BULLETIN # SPSB005

SUBJECT: HIP RING AND 4 RING MAIN LIFT WEB INSPECTIONS

STATUS: MANDATORY

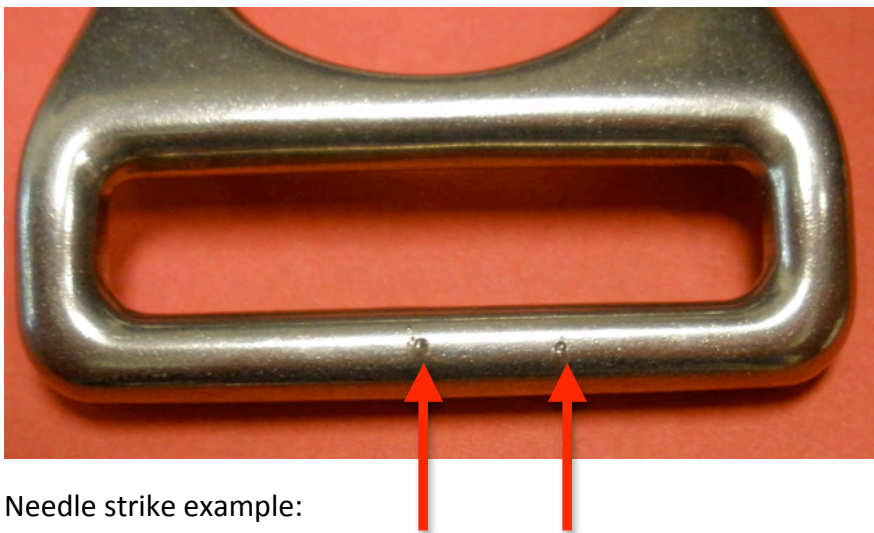
Needle strike example:

It has been brought to our attention that the hip ring on JH101-3 (Hip Ring Only) and JH101-4, (4-Ring) main lift webs, may have been struck by the needle used for installing the 5 cord harness stitching. This needle strike on the hip ring may cause damage to the Type 12 buffer, 5 cord stitching and possibly the Type 7 webbing. As a precaution, a mandatory inspection of the hip rings is required for all systems with a date of manufacture between September 2008 and December 2008.

The picture below is an example of a needle strike on an SR8 hip ring.

1. If damage is found or suspected, the harness/container will need to be sent to Sun Path Products, Inc. for repair. Please ship to the following address and include a completed Hip Ring Damage Repair Form found at the end of this document:

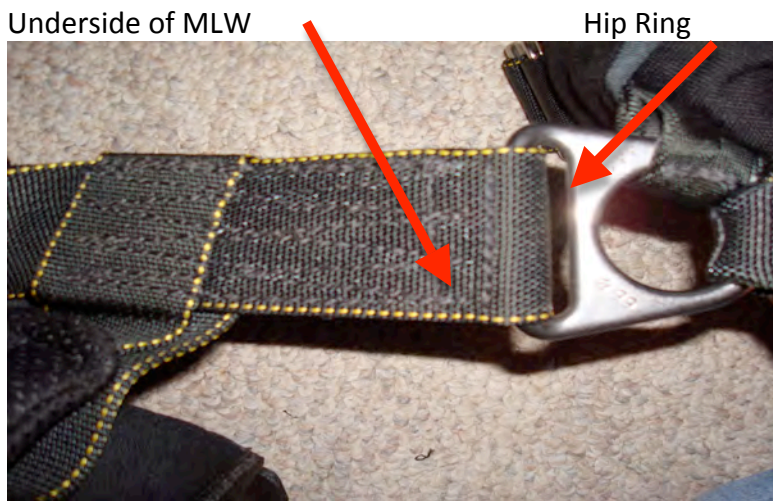
Turn Main lift web over, to expose the underside of the MAIN LIFT WEB (MLW).

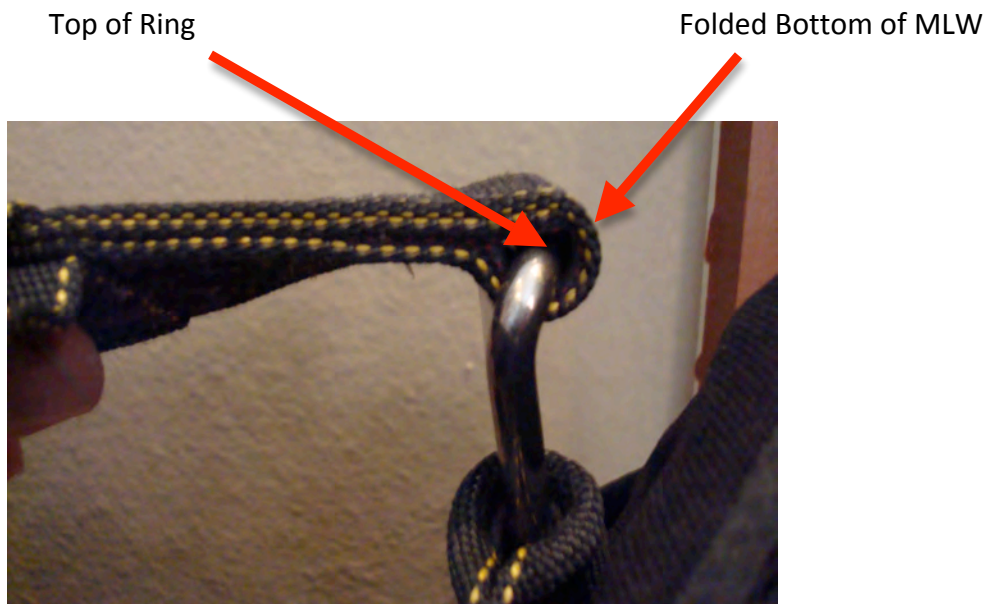
5. Rotate Hip ring and leg pad 90 degrees downward as to expose the top of the ring to the inside of the folded bottom end of the MLW webbing, as shown below.

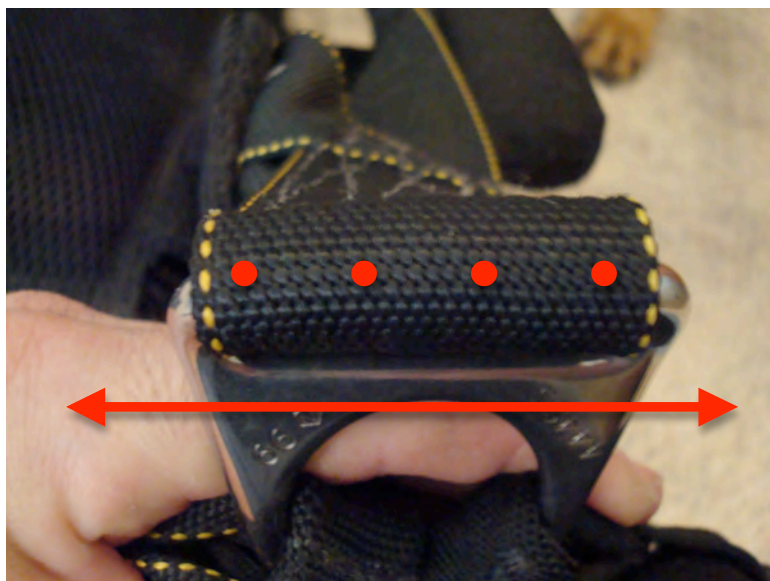
6. Move the hip ring back and forth (side to side) and rotate inside the webbing, while pressing the top of the ring through the webbing. If a needle strike is present, the rough spot on the top of the webbing bar of the ring will catch or snag on the TYPE 12 buffer on the inside of the TYPE 7 MLW. This will feel like a rough spot(s) on the top of the bar and cause a rough or snagging feel.

FEEL HERE FOR DAMAGED RING INSIDE WEBBING. DAMAGE WILL MOST LIKELY BE ALIGNED WITH THE BOTTOM POINTS OF THE 4 POINT STITCH PATTERN.

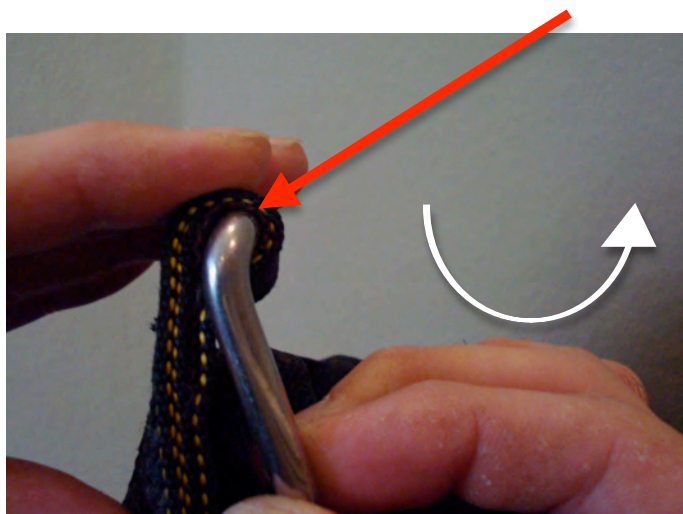
WHILE ROTATING, FEEL HERE FOR NEEDLE STRIKE.
