Emergency canopy P512 (P/N 2004710600).

Harness container FLEXPACK (P/N 80020130 or 8002013000)

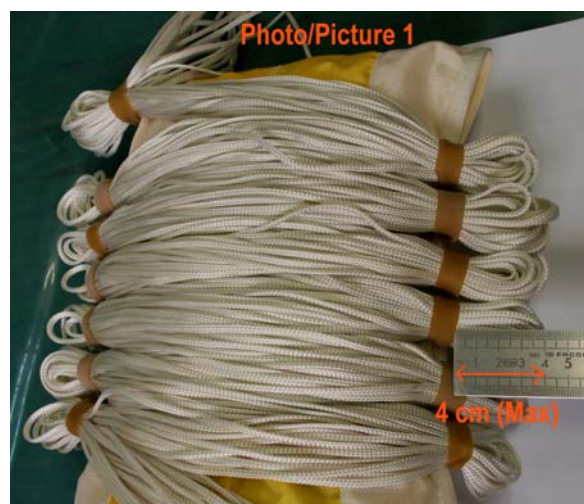
The damages are due to one or more overlins causing the damage of several panels. It is likely that this incident is due to one or more lines passing over the diaper during the extraction of the container.

- The length of each stow should not exceed 4cm. **Cf Picture 1**,
- The packer will have to limit the length of lines not stowed (between the last stow and the links on the risers) by adding rubber bands if necessary,
- The length of lines between the last stow, and the links on the risers should be 25 cm as a maximum **Cf Picture 2**,
- The packing with diaper on the top of the container is cancelled. The only possibility is now to put the diaper at the bottom of the container **Cf Picture 3**.

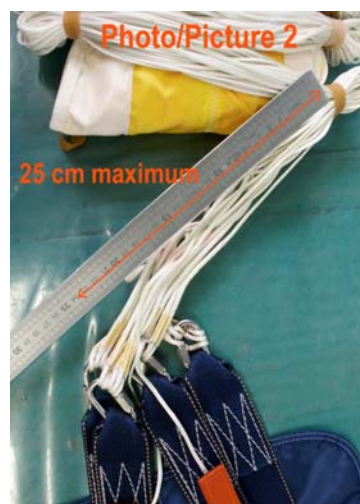
- if there is too much lines not stowed on the diaper,
- if the stows are too long.
